Gremlins Live in Helicopter Engines

George Adams and Chuck Hagen – Contributing Authors

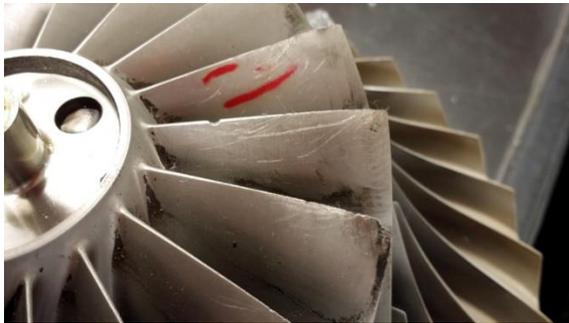
Human factors/FOD- Complacency

FOD is generally caused by a lack of attention to detail. Leaving a cleaning rag on an engine deck when replacing panels and subsequently sucking it into the engine is avoidable, but it does happen. Forgotten tools, dropped hardware, etc., all become possible FOD and accident investigation findings. Another problem we see is leaving metal filings on a deck following the completion of a sheet metal repair or alteration. These filings can be ingested into the engine leading to engine damage caused by FOD.
